**CONDITION ASSESSMENT OF
ELECTRICAL APPARATUS:
A BUILDING BLOCK FOR ASSET
MANAGEMENT**

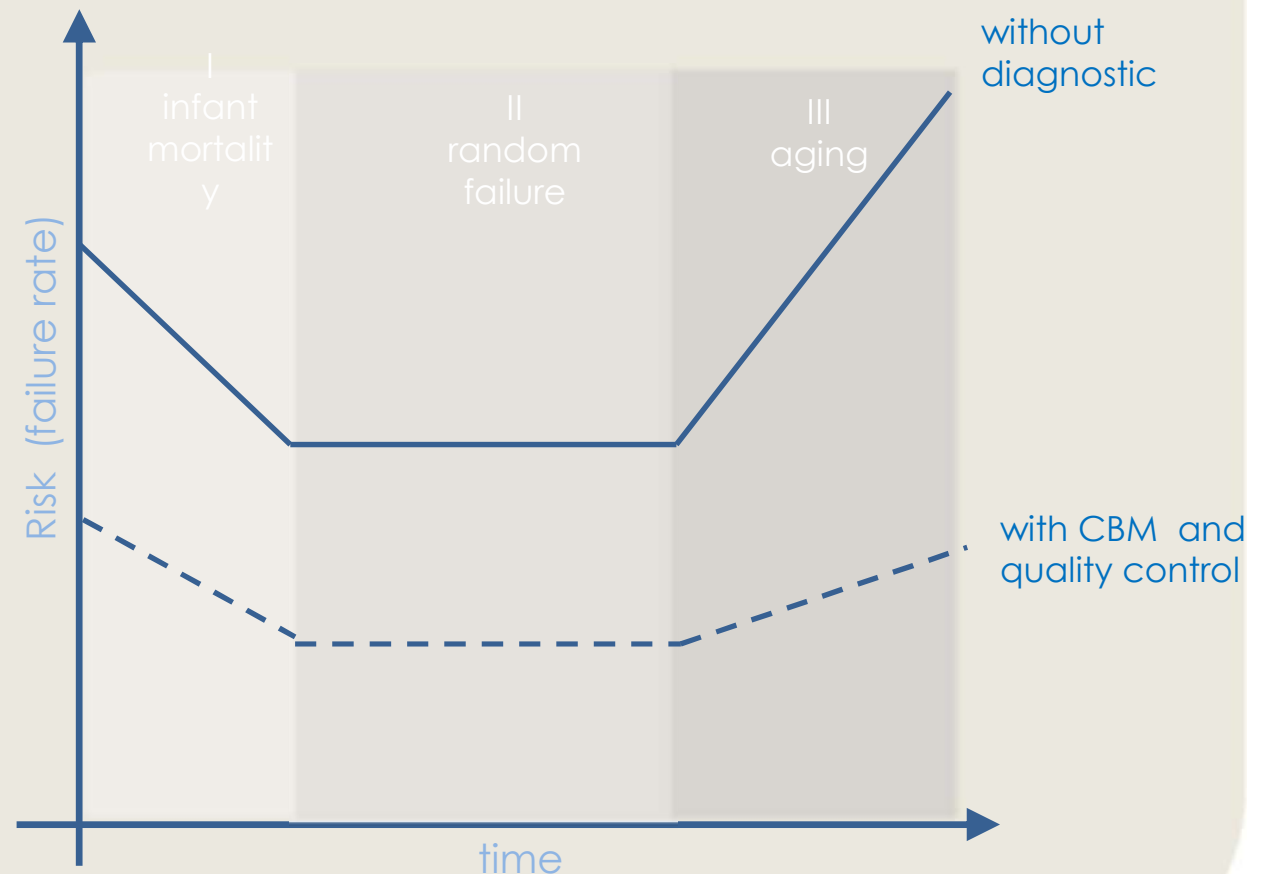
"bathtub curve" according to the failure rate

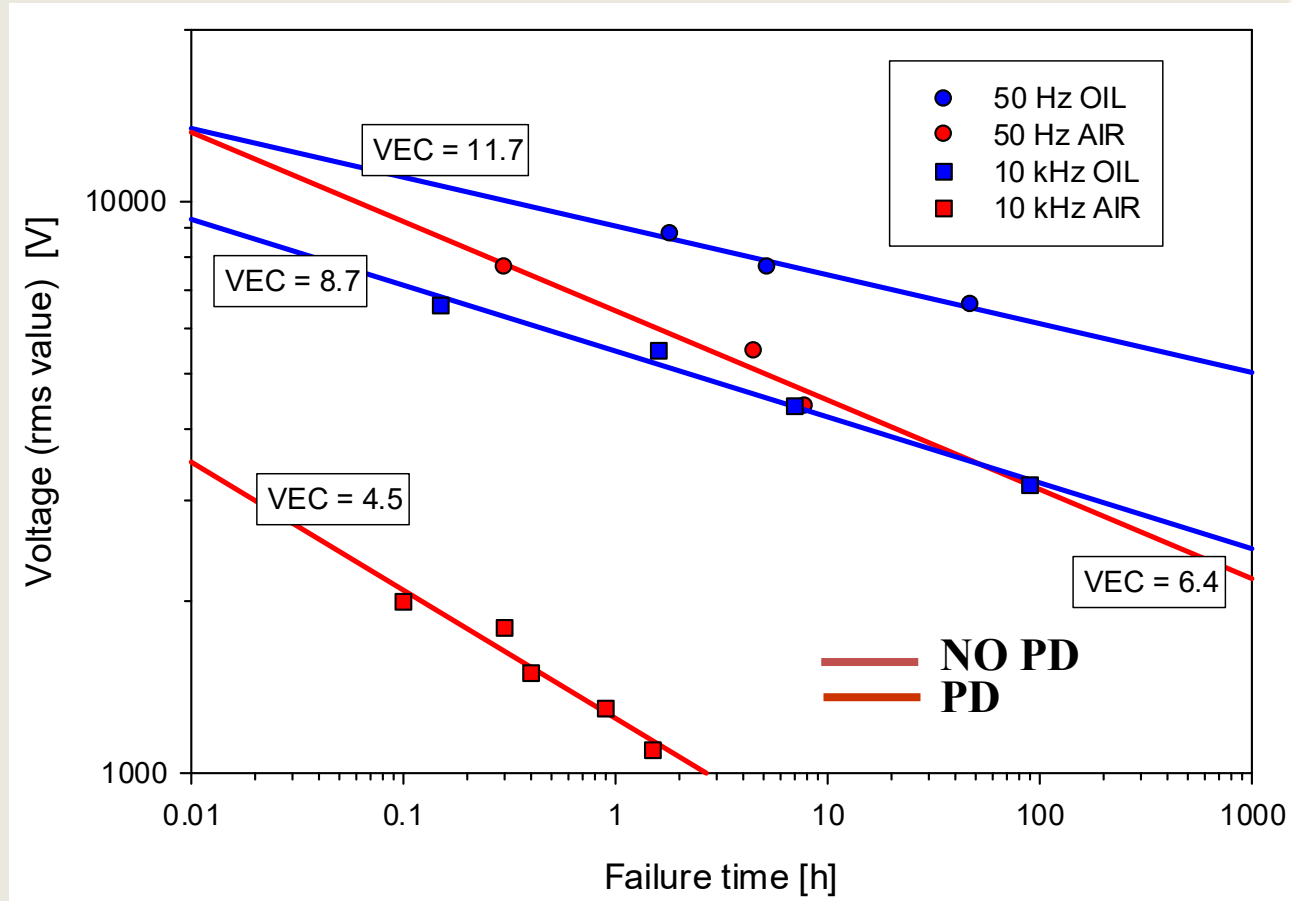
Life lines for tests performed in air and in oil at 50 Hz and 10 kHz sinusoidal (organic material, #A).

- Life and VEC decrease at 50 Hz in the presence of PD
- Life and VEC decrease as frequency increases in the absence of PD
- Dramatic life shortening (and VEC decrease) at 10kHz due to PD activity amplification

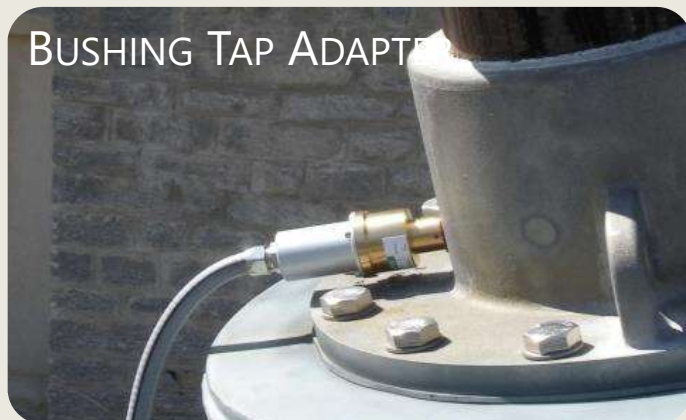
DIAGNOSIS BY ON-LINE MONITORING BUSHING TESTS

Real time evaluation of the behavior of capacitance and $\tan\delta$ parameters. This is of outmost importance in case of "fast failure modes", like a short circuited layer or PD in bushings..

Time trend is fundamental to decide the proper maintenance time (on line monitoring)

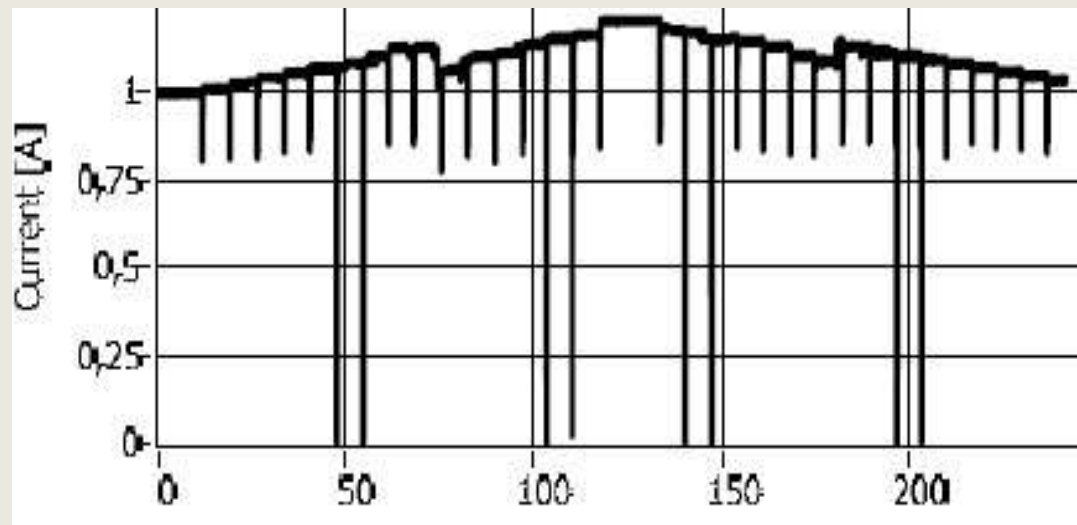
Example of Unhealthy Tap Changer

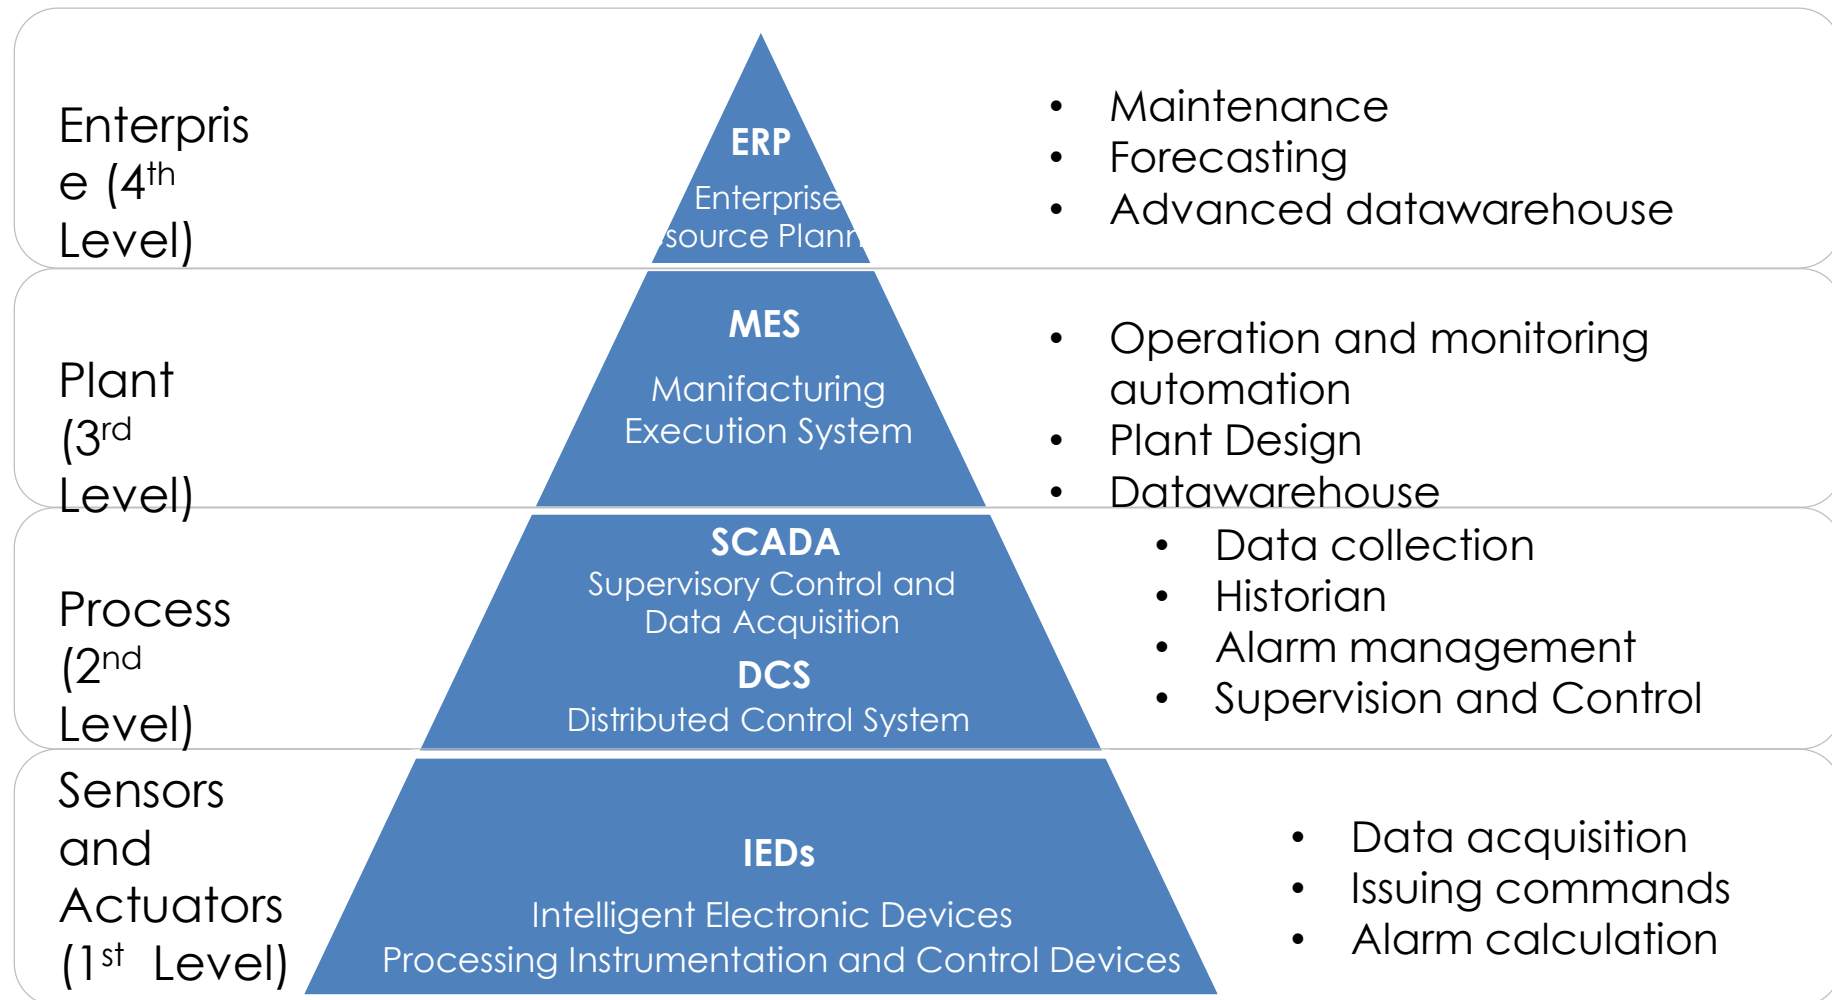
Global TiSCADA - Architecture

TiSCADA designed on a Service Oriented Architecture (SOA)

Software design based on structured collections of discrete software modules, known as services, that collectively provide the complete functionality of the software application. Each service that makes up an SOA application is designed to provide a tightly defined set of functions.

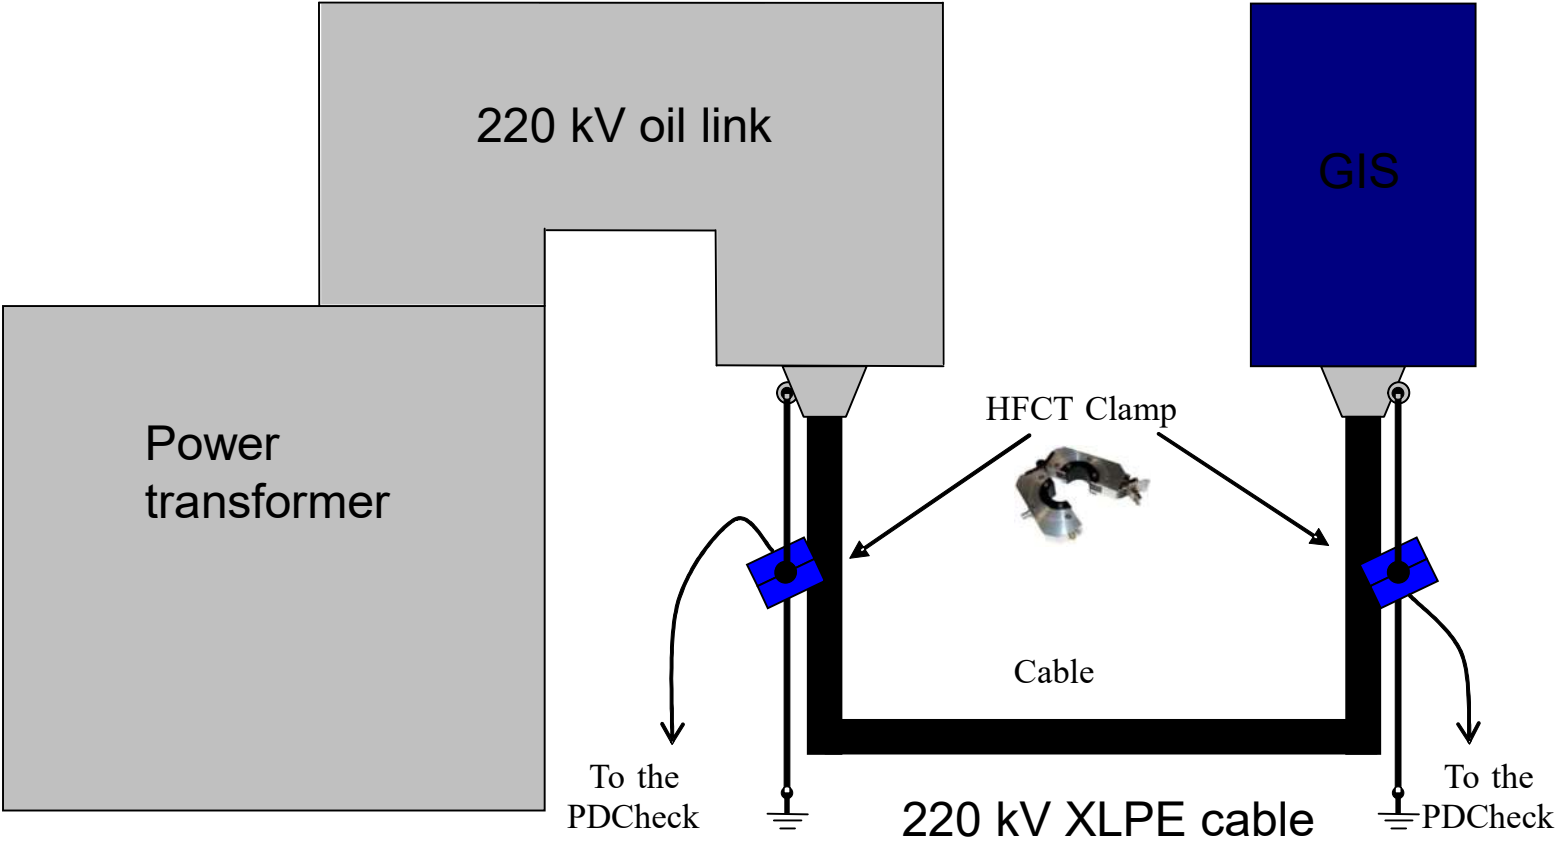
On line PD test on Transformer/Cable: PD measurement layout

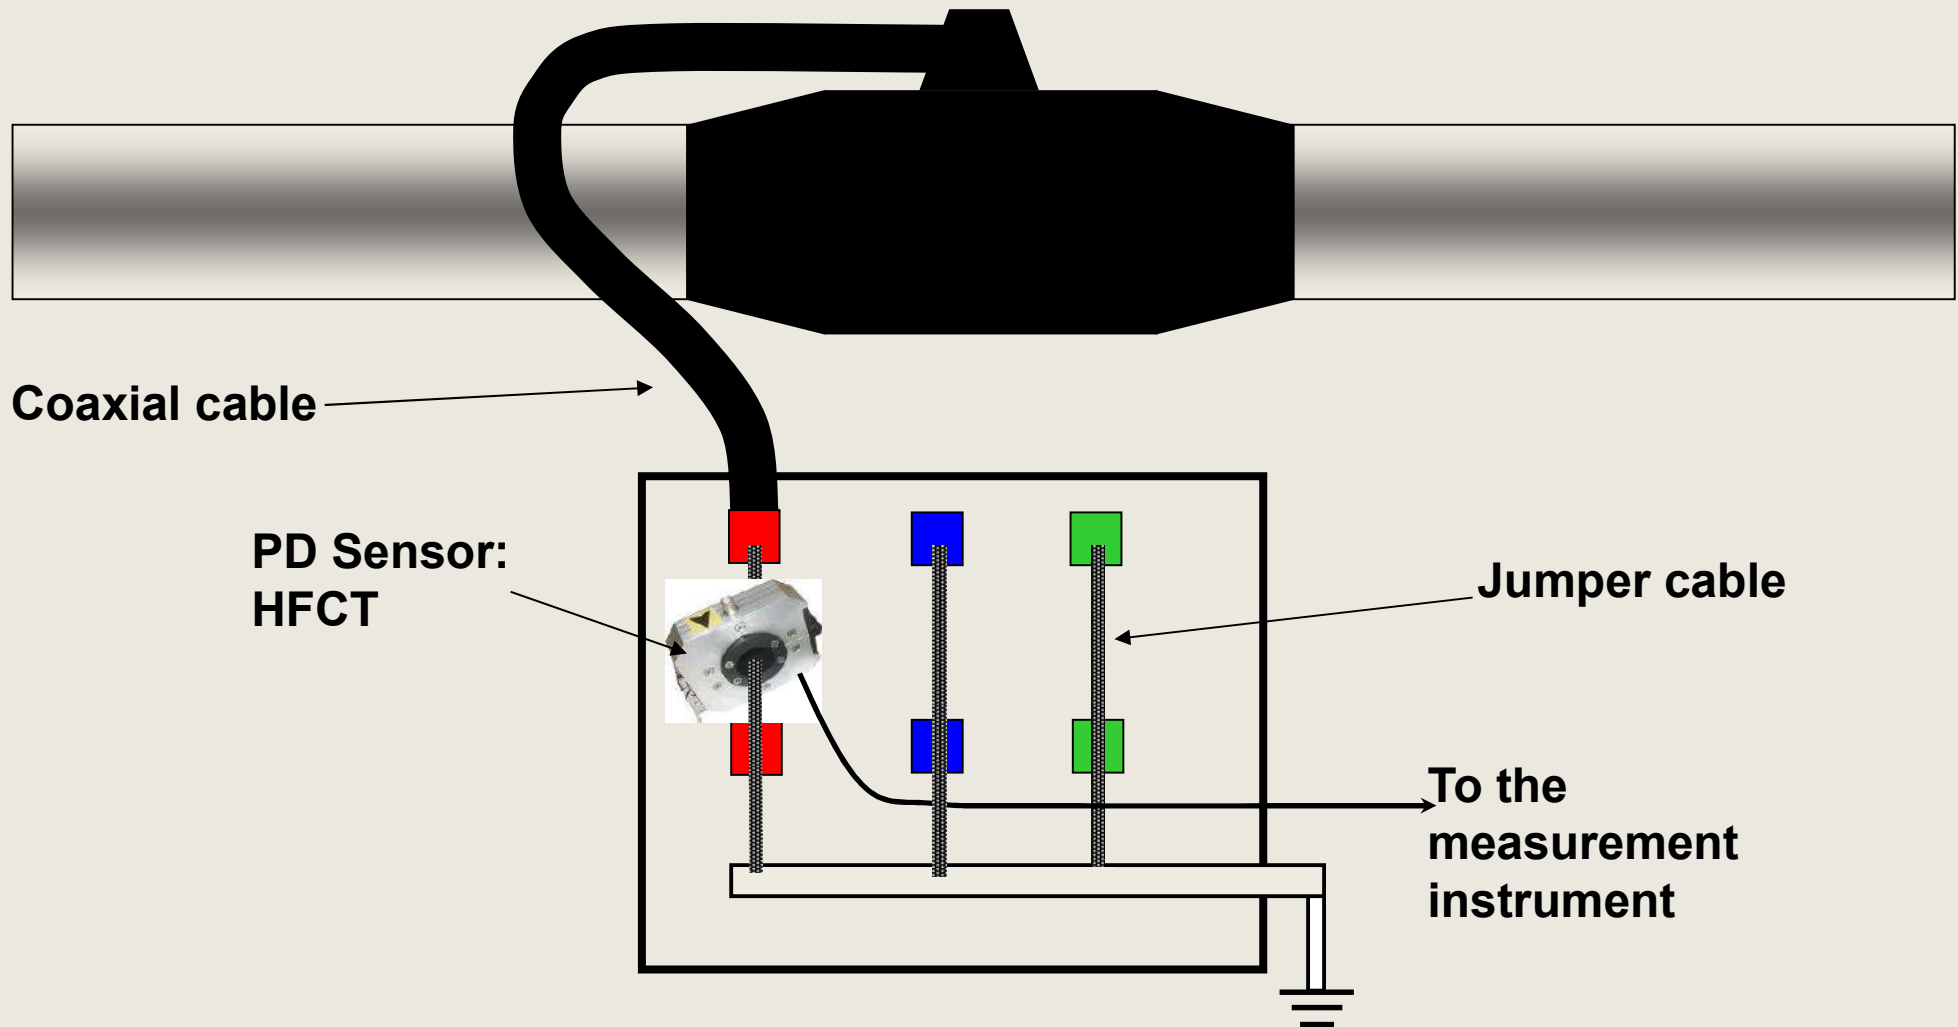
On line PD test on EHV Cable: PD detection
